Price River Canal Drainage Assessment 2008

Carbon County GIS Dept.

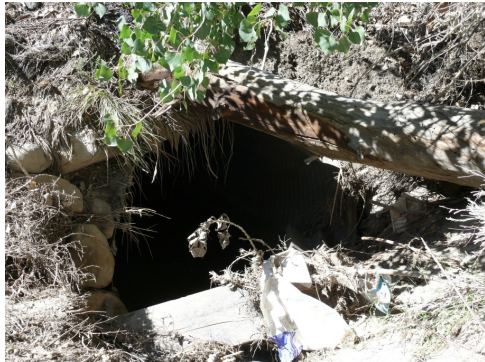
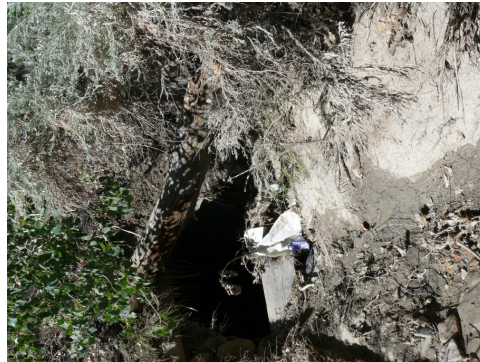
Pictures A. & B. show where the water enters underneath the railroad tracks that run east to west towards Spring Glen Road. The culvert is semi-blocked by debris.

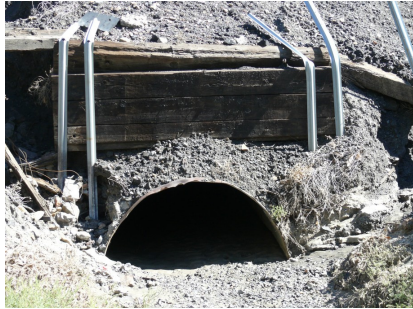
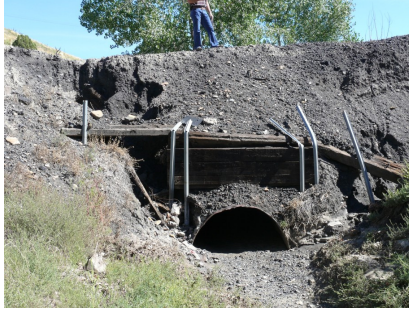
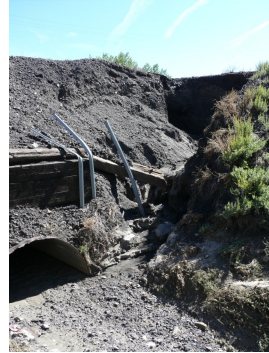
Picture E, D, & E show where the water comes out underneath the railroad tracks that run east to west towards Spring Glen Road. As you can see, the culvert is washing out.

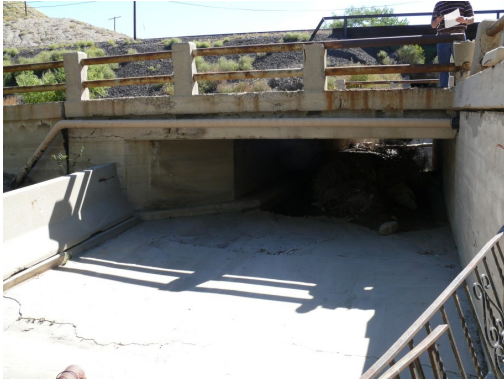
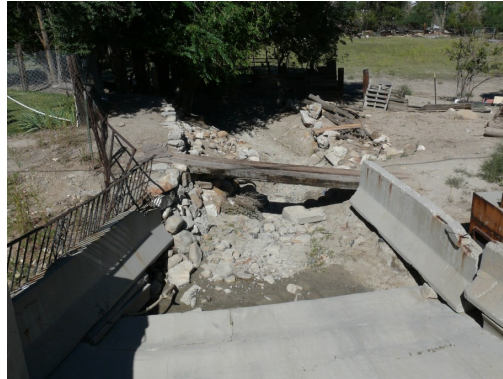
Pictures I & J are on the west side of bridge traveling towards Helper. They show where the water comes out underneath the road towards the Price River.

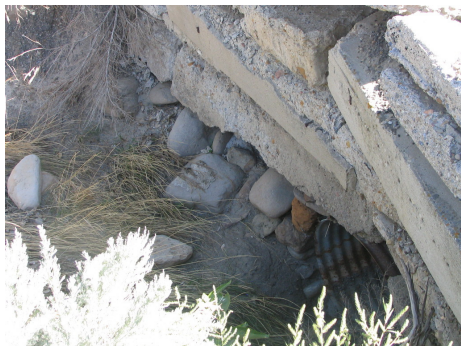
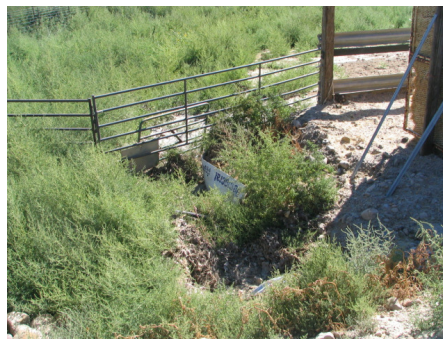
Picture A shows where the water comes out from underneath the road towards Matthew's pasture. Picture B shows where the water enters into a pipe along Matthews pasture. As you can see from the picture, it is clogged with debris.

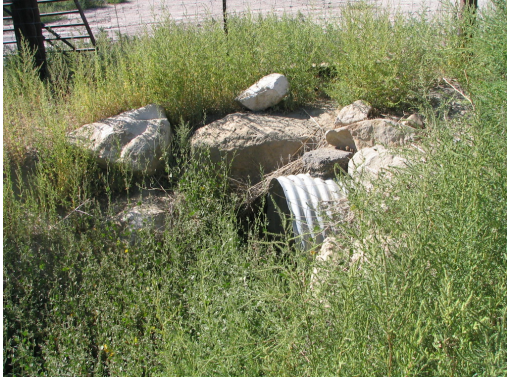
C.

Picture C shows where the water comes out of the pipe along Matthew's pasture. It runs parallel along the fence line and railroad tracks.

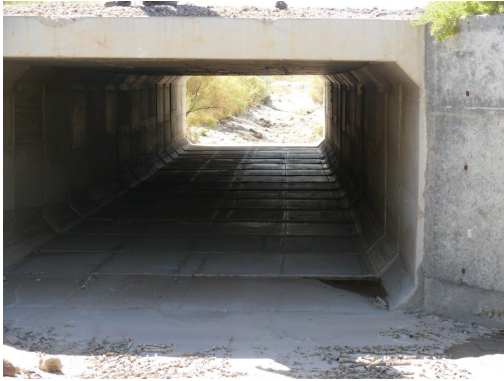
B.

the road.

Picture B shows where the water comes out underneath

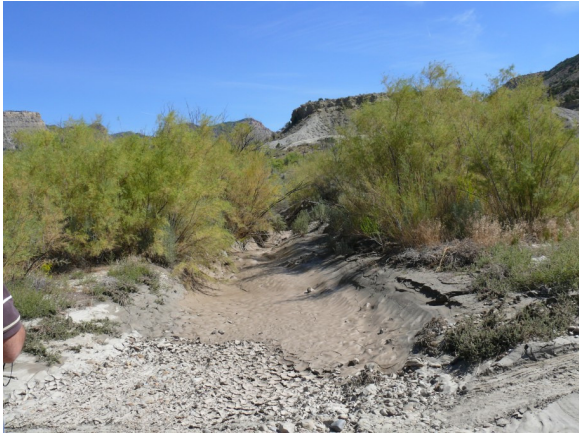
C.

road. The wash crosses directly over the road.

Picture C shows where the water crosses the dirt

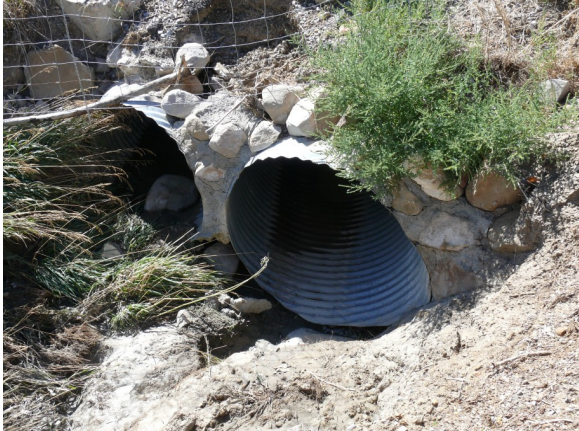
F.

Picture F shows where the water enters into the culvert under Kenilworth Road (heading south) by Saccomanno's property. We spoke with Mr. Saccomanno and he stated that he keeps the culvert cleaned out so it doesn't flood his property.

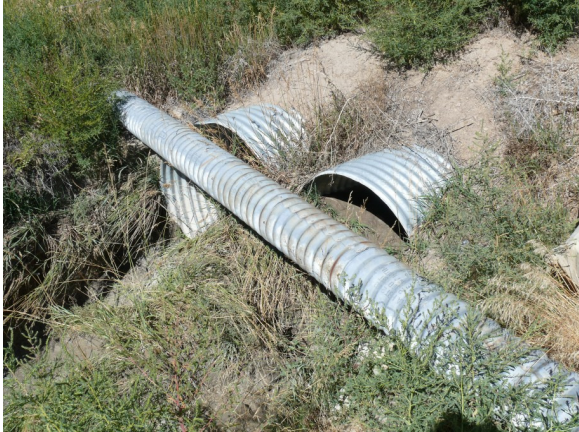
G.

Picture G shows where the water comes out of the culvert underneath Kenilworth Road across from Saccomanno's property.

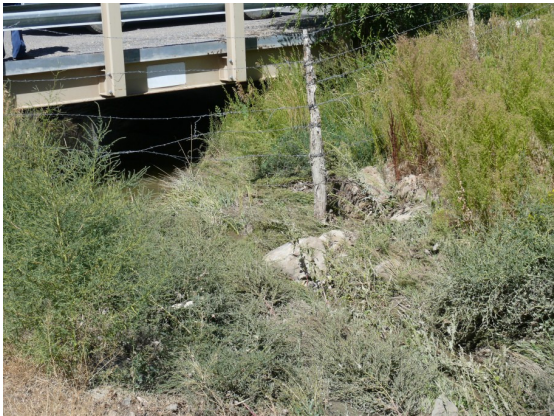
H.

Picture H shows where the water goes under the bridge parallel next to the road North of the Spring Glen Park.

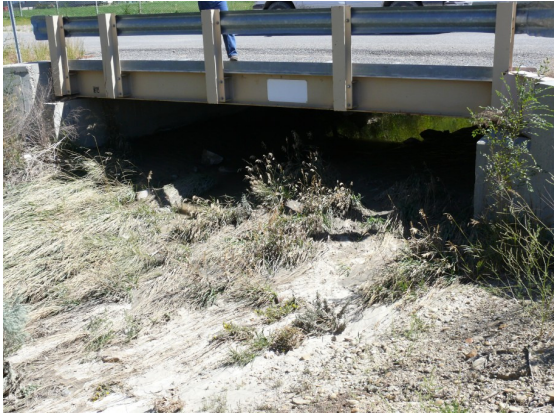
I.

Picture I shows where the water comes out under the bridge next to the road that runs parallel to the Spring Glen Park.

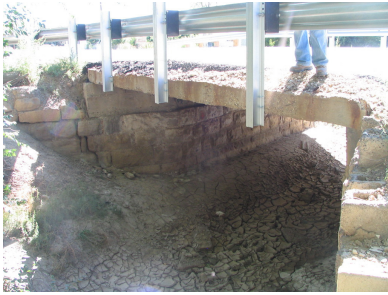
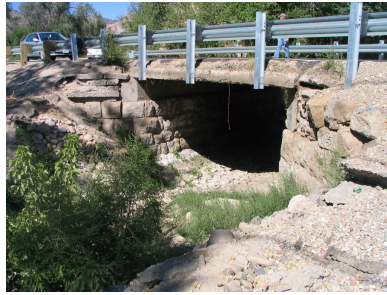
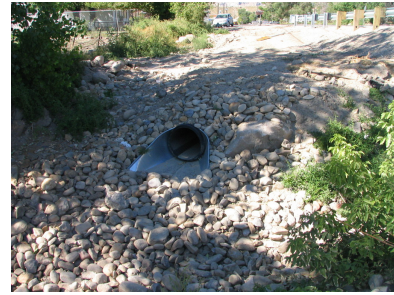
Pictures J, K, & L. show where the water enters and exits under the road by the Slovenian Home in Spring Glen.

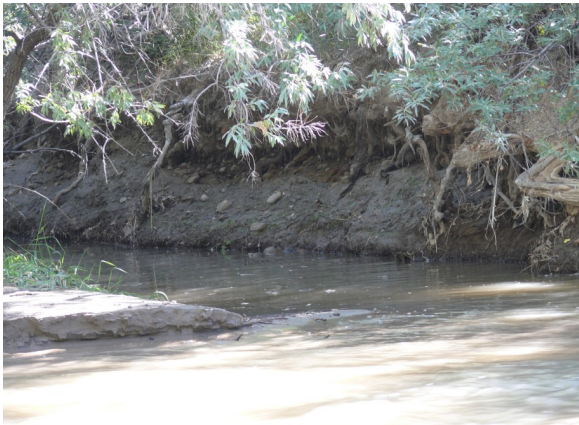
O.

Picture O shows where the canal runs into the Price River. It is behind the Sacco's property on HWY 6.

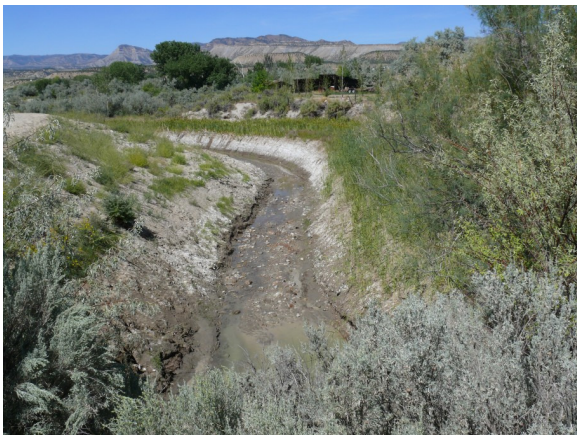
Pictures C & D show where the wash crosses under the road and comes out south of Hunsaker's property.

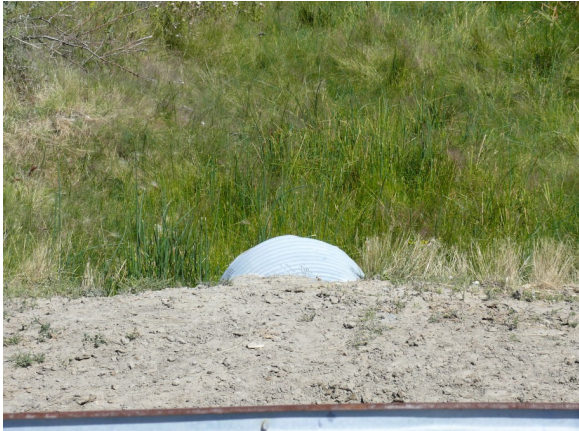
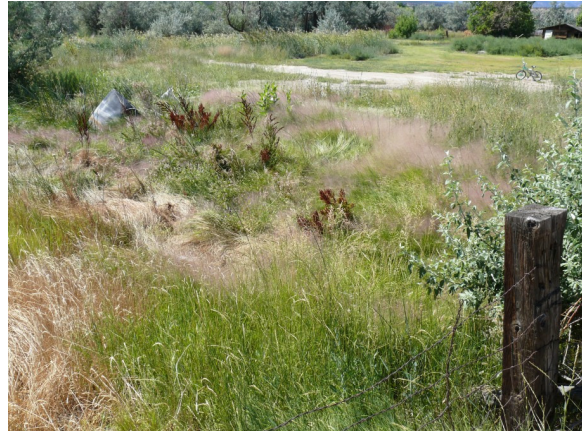
G. H.

Pictures G & H show where the drainage crosses under and comes out under the road south of Ike Fazzio's property.

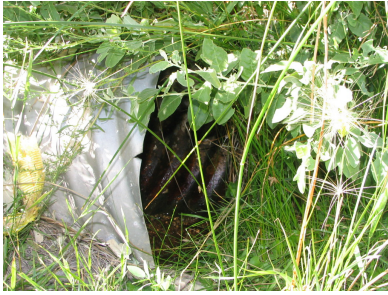
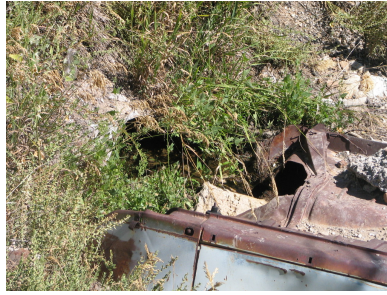
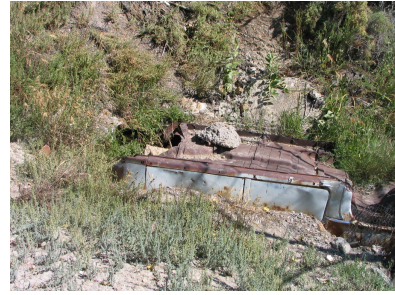
I. J. K.

Pictures I., J., & K., show pictures of the drainage going into a culvert under the road and coming out. This is north of Dahl's property. As you can see from the pictures, pictures I. & J. have an old car in the way where the culvert comes out from under the road.

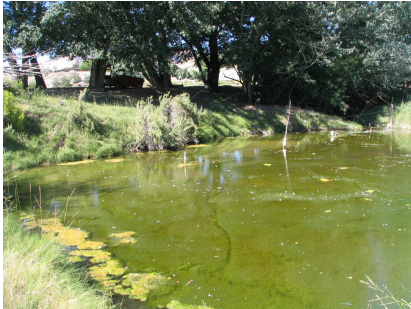
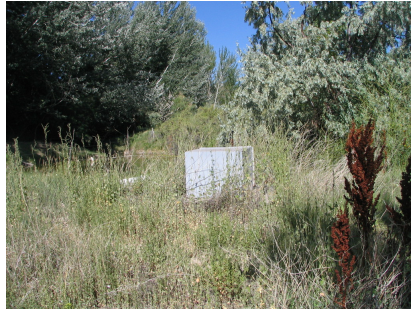
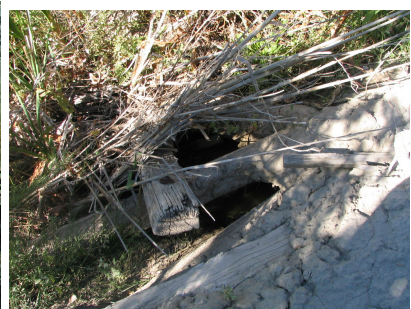
L. M. N.

Pictures L., M., & N., show pictures of the drainage going into a pond and coming out heading south.

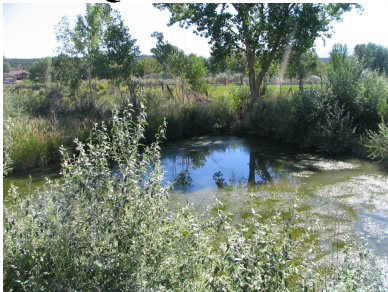
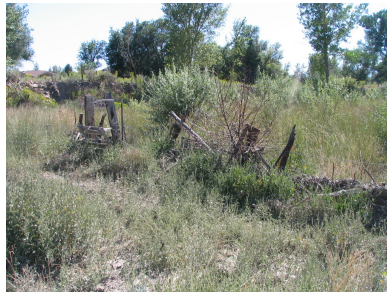
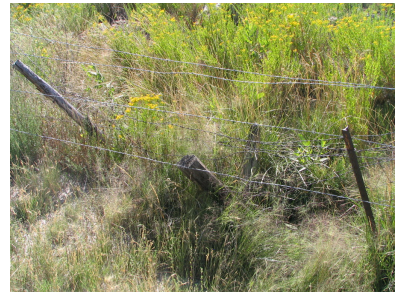
O. P. Q.

Pictures O., P., & Q., show pictures going into another pond and coming out to rejoin with the Spring Glen drainage.

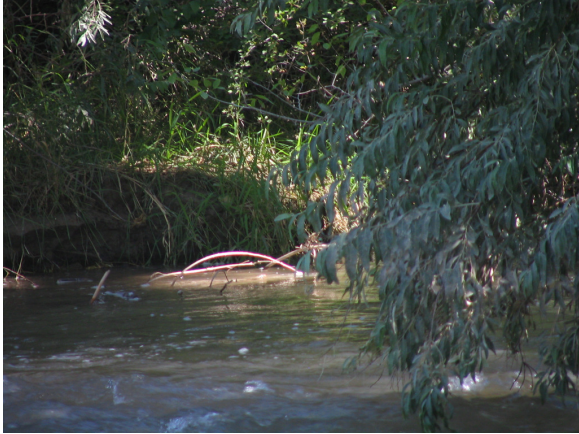
Pictures V. & W. show where the drainage runs into Price River by Simm's property.

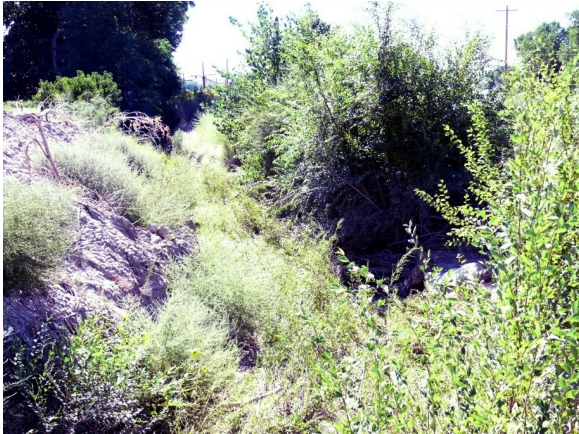
E.

Picture E shows the view looking south.

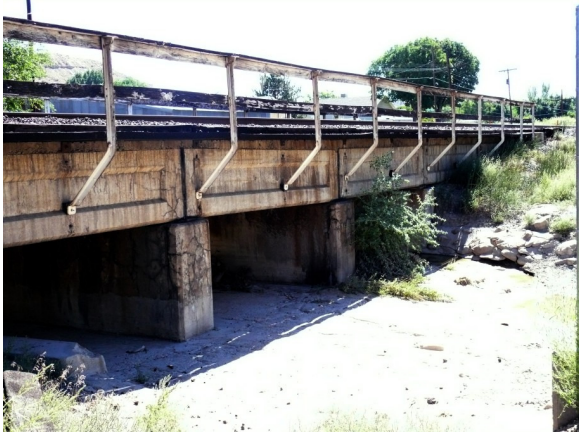
G.

Picture G shows the west side of the railroad crossing.

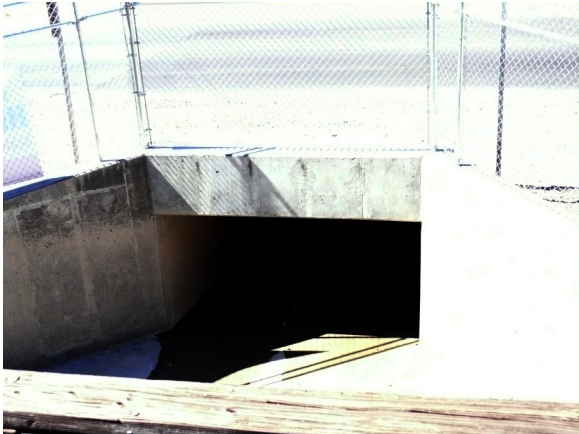
H.

Picture H shows the east side of the culvert going under Carbonville Road.

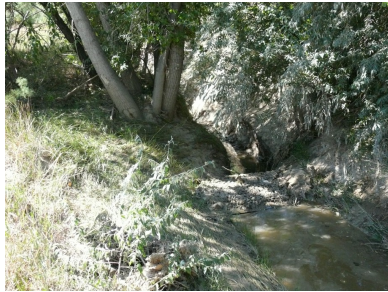
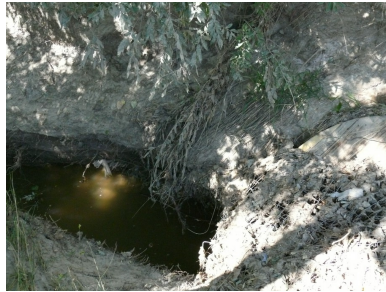
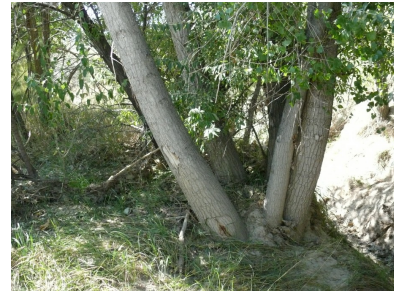
Picture J is a picture of an obstruction. Picture K is a picture looking down on obstruction. Obstruction appears to be a cable spool. At the tree in picture L, the water flow splits due to the obstruction. Some of it travels to the left out of the image and towards the trailer park.

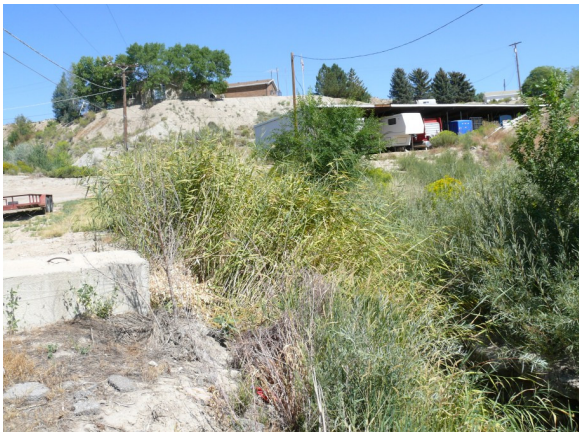
A.

Picture A is looking up the drainage at the Jensen's property line.

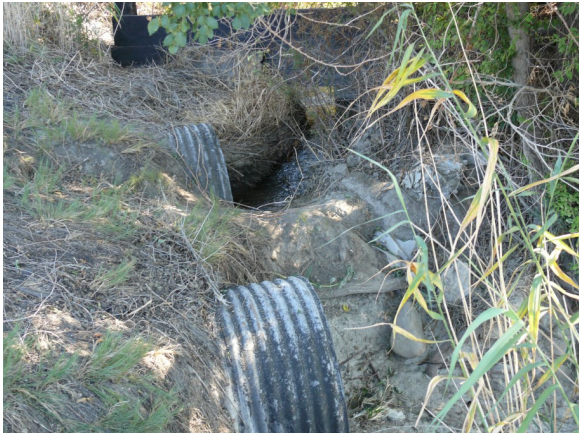
D.

Picture D shows the culverts on the west side of the railroad tracks. The culvert at the top of the image carries irrigation water.

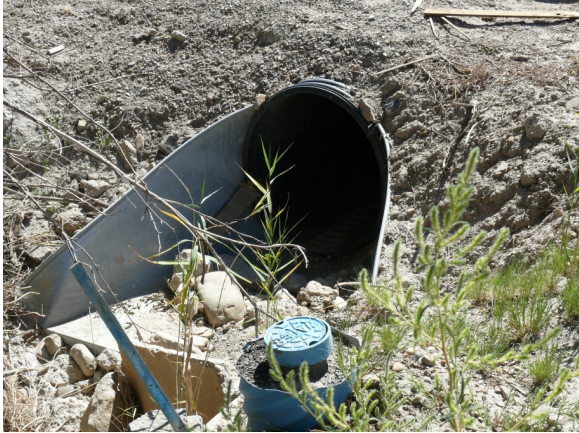
E.

Picture E shows the culvert underneath Carbonville road on the east side. The west side of the road goes directly into the drainpipe that heads towards the river.

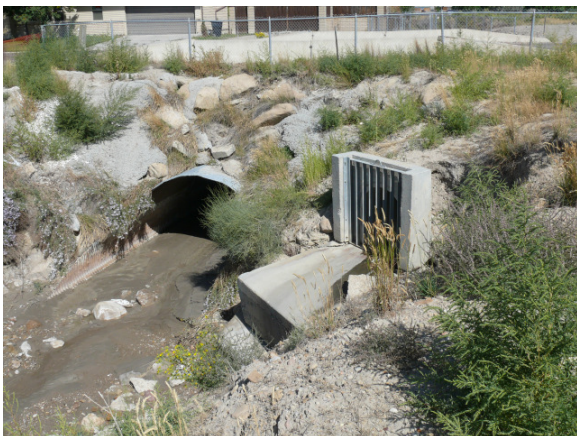
C.

Picture C shows south of the road.

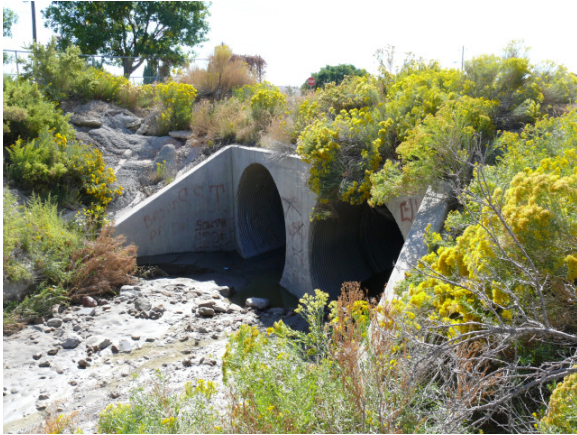
D.

Picture D shows north of the road.

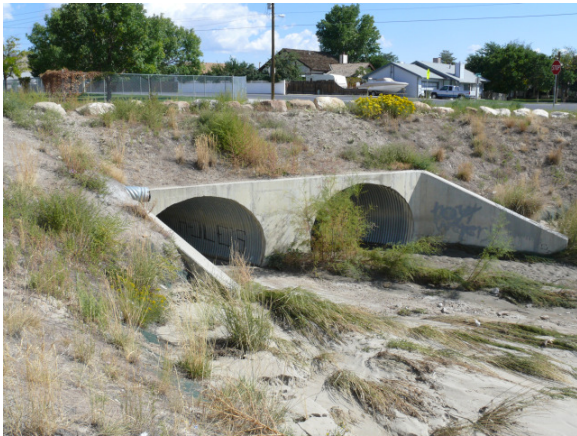
E.

Picture E shows south of the road.

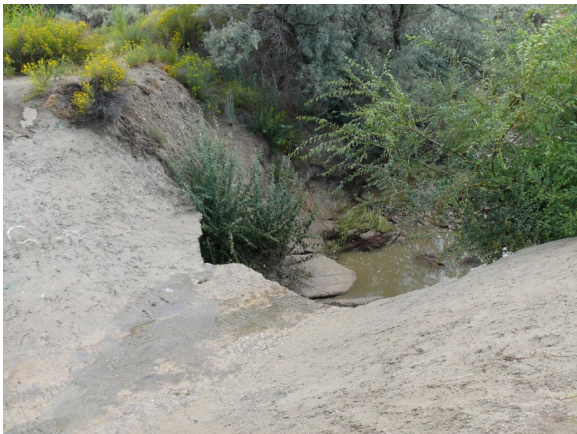
F.

Picture F shows where the canal crosses under a road.

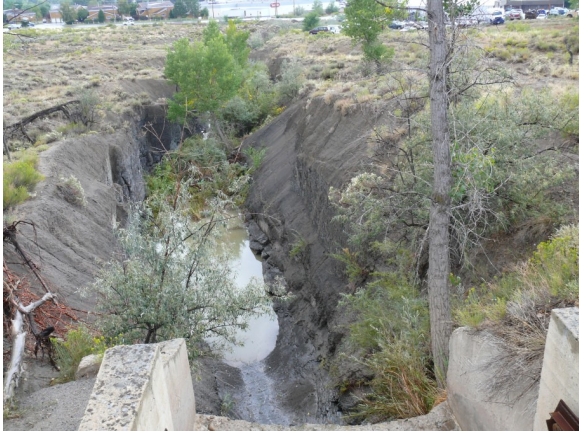
G.

drainage heading south.

Picture G shows where the canal dumps into the

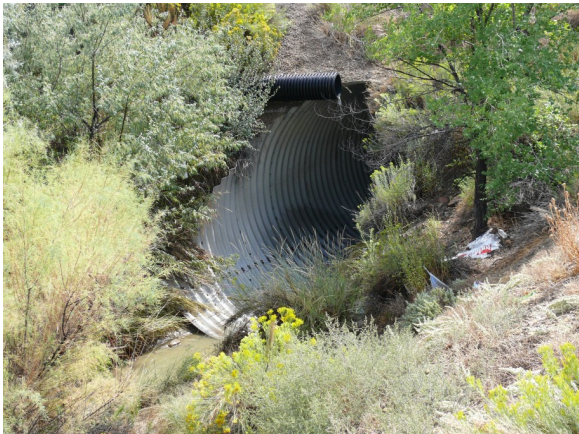
H.

the road by Krompel's Carwash and Smith's.

Picture H shows where the drainage goes under

**Pictures H & I connect somewhere under the road and come out at picture J.*

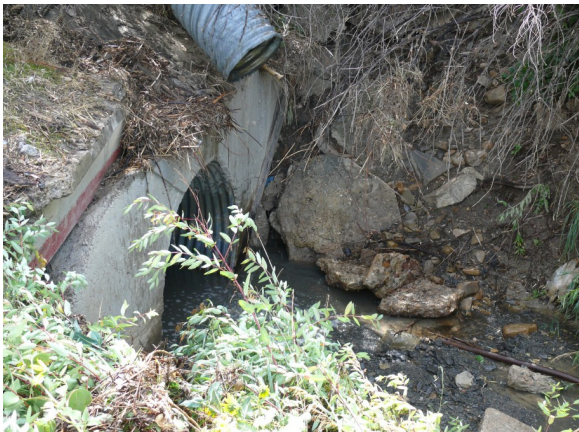
I.

road by Krompel's Carwash and Smith's.

Picture I shows where the drainage goes under the

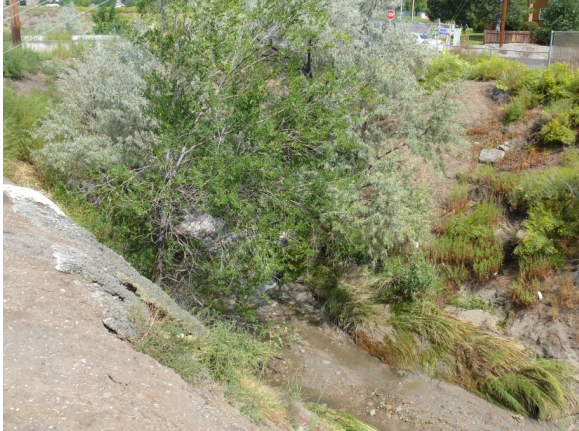
J.

Picture J shows where the drainage comes out by Krompel's Carwash and Smith's on 1st North.

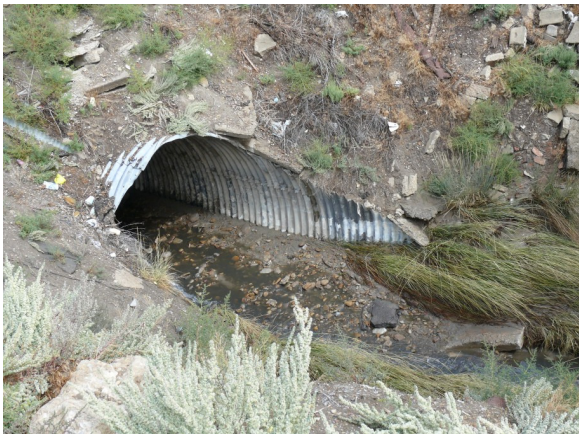
L.

Picture L shows where the drainage exits underneath Main Street by the Eastern Utah Credit Union.

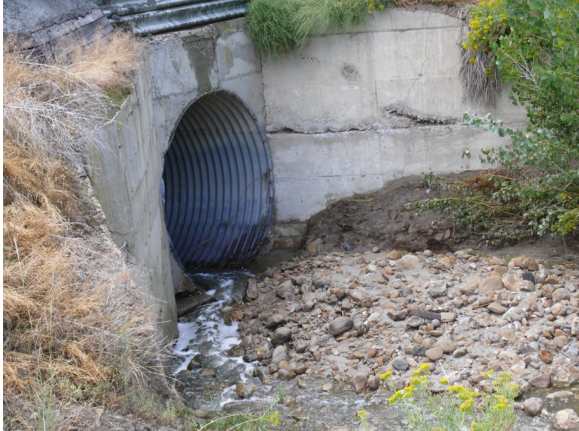
M.

the road on 4th South.

Picture M shows where the drainage enters under

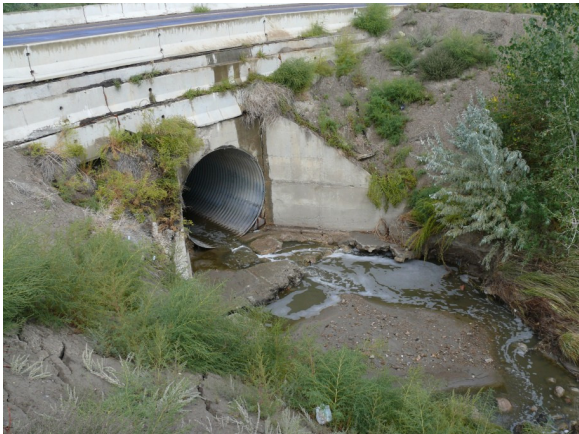
N.

underneath the road on 4th South.

Picture N shows where the drainage exits

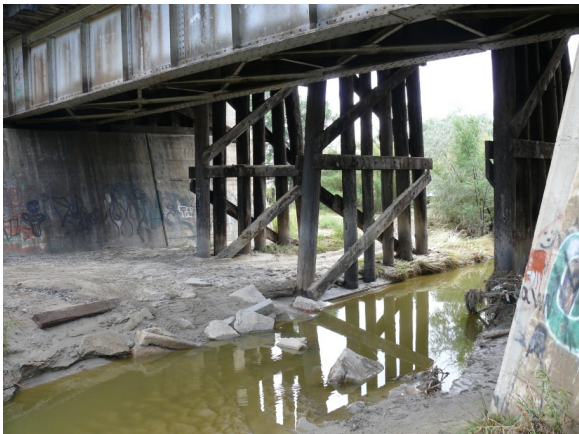
O.

the railroad by City Sanitation.

Picture O shows where the drainage goes under

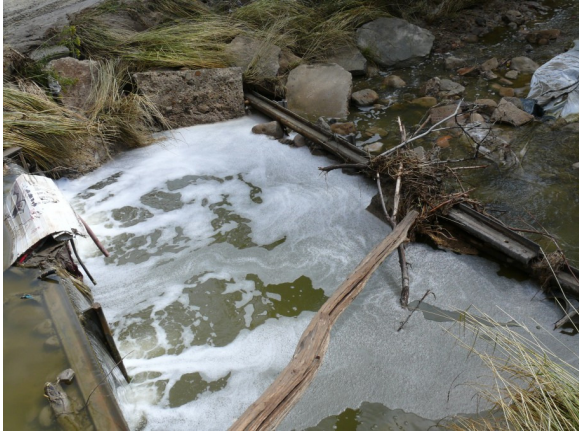
P.

underneath the railroad by City Sanitation.

Picture P shows where the drainage exits

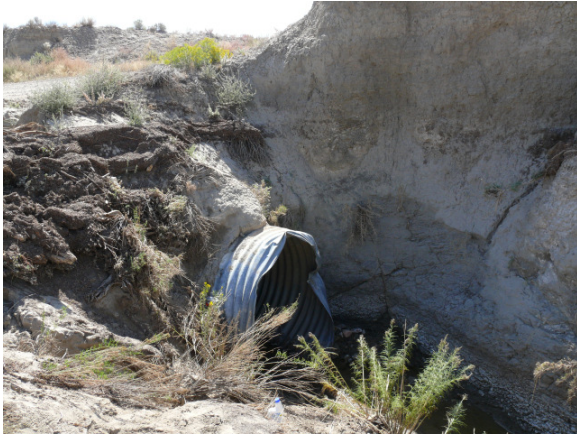
Picture A. shows north of the road.

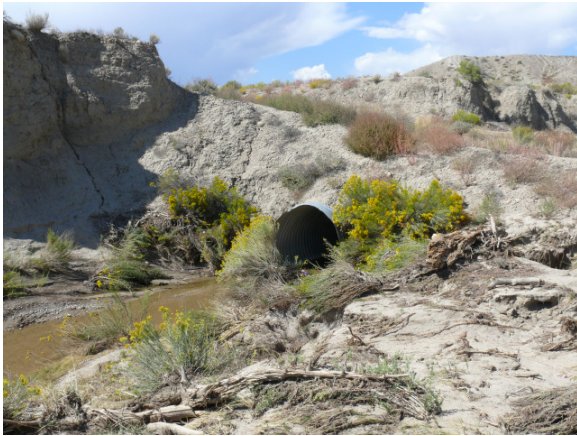
B.

Picture B shows south of the road.

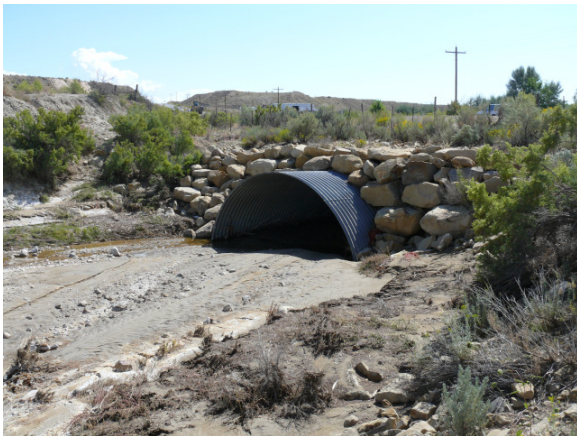
C.

Picture C shows north of the road.

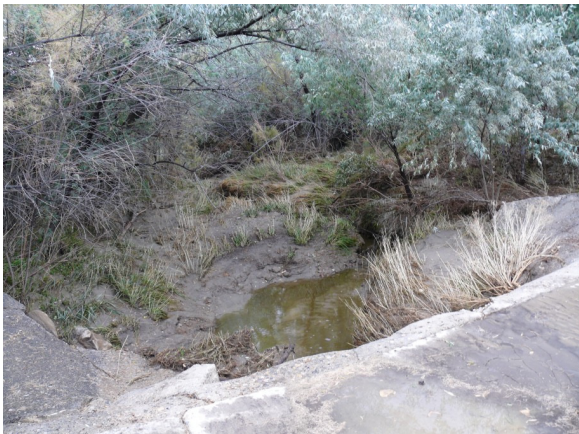
Pictures F & G show the Bawdenville drainage crossing. As you can see from the pictures, the high water mark exceeds the culverts capacity.

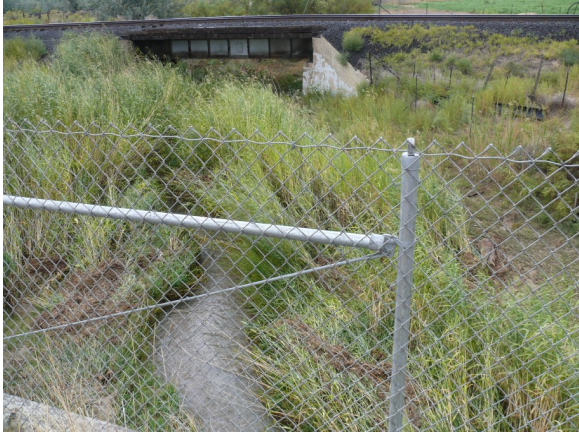
I.

Where drainage comes out from underneath HWY 6 towards Wellington from Price. You can see where the drainage goes under the railroad tracks and towards the Price River.

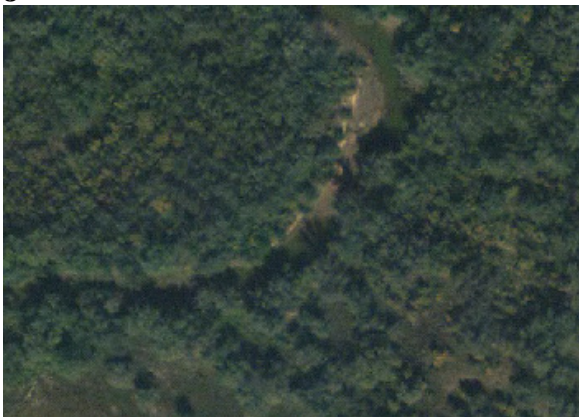
J.

Picture J is an aerial photo of the confluence.

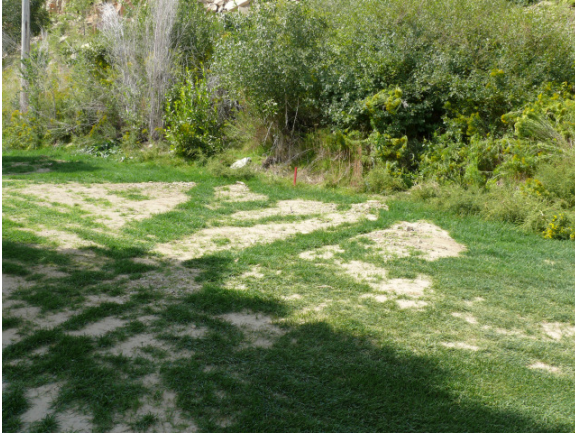
B.

Because of the absence of the catch basin picture
B illustrates silt-laden runoff coming off the hill onto the course.

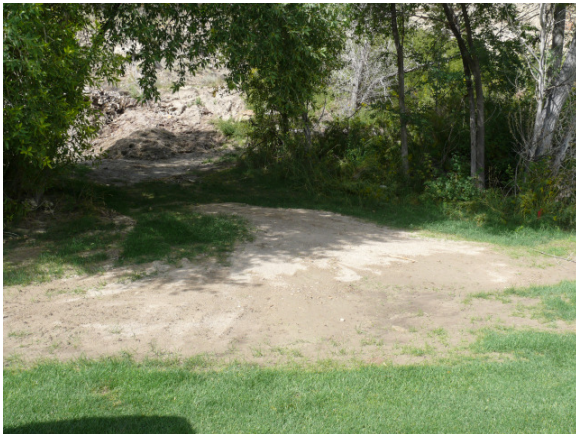
C.

More silt being deposited on the course near #7
fairway from runoff.

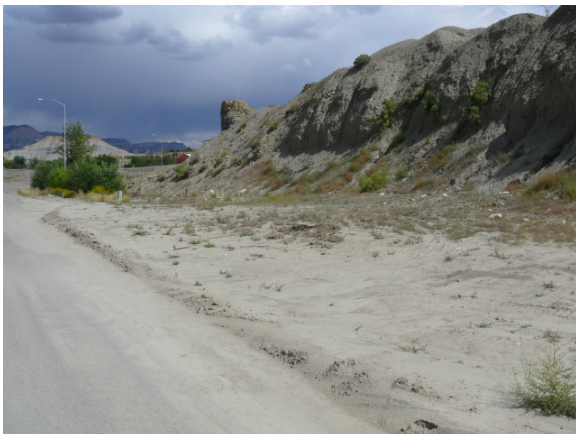
D.

Picture D shows silt being deposited near the
parking lot at the entrance to the golf course, due to a lack of proper drainage around or
underneath.

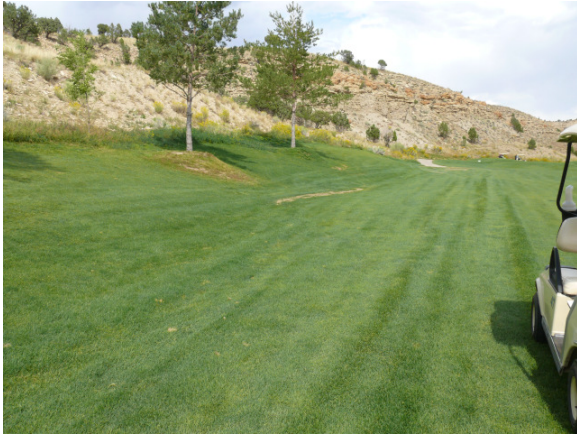
E.

Pictures E and F illustrate a natural drainage that runs a portion of the course, which needs to be addressed with, further flood control engineering.

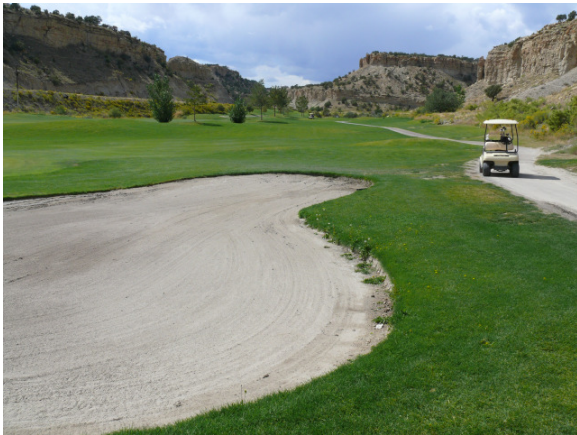
G.

Pictures G and H illustrate another drainage issue from the north side of a fairway. As you can see the topography lends itself to becoming flooded unless new ditches are created. Picture G shows a sand trap that is sometimes completely filled with water during heavy rains.

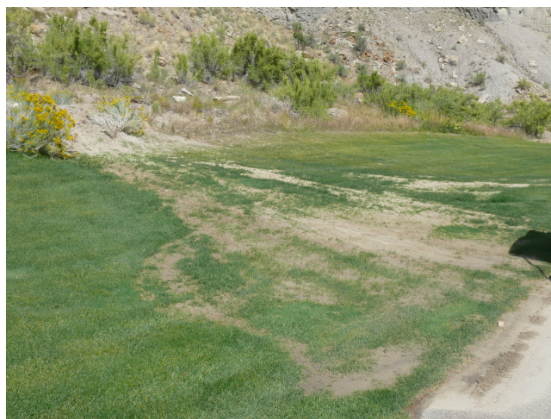
I.

accumulating onto the course.

Picture I shows again more silt

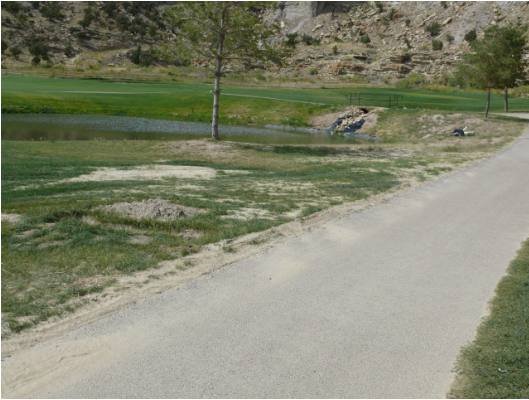
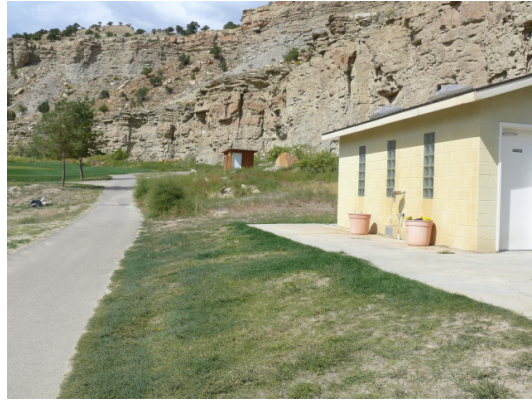
Pictures J and K illustrate more drainage issues running across the path and onto the course.

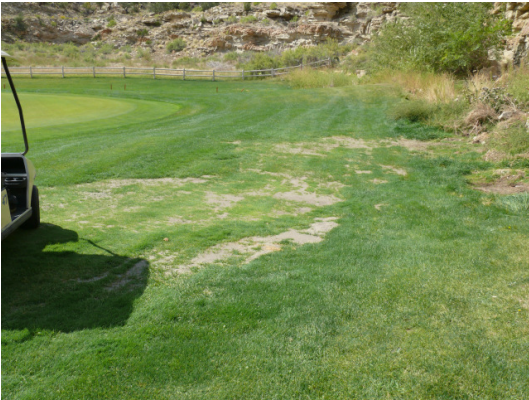
L.

Picture L shows more silt onto course.

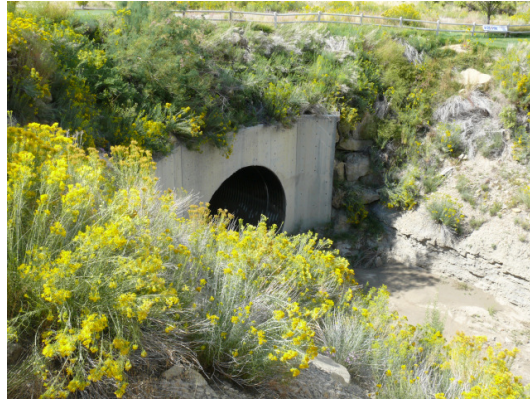
O.

Pictures N and O show the water course in Garley Wash from the west side of the course path (N) to the east (O). In picture O you can see the high water mark against the blue shale.

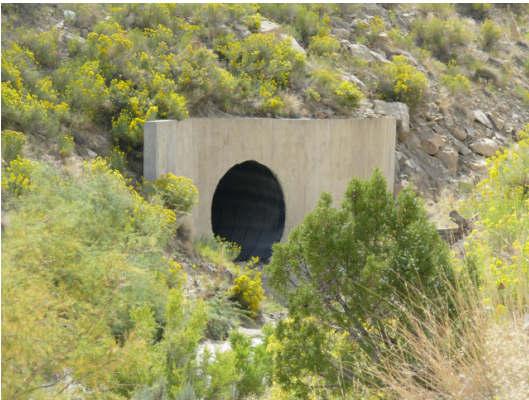
P.

Picture P shows the culvert existing underneath the road west of the golf course.

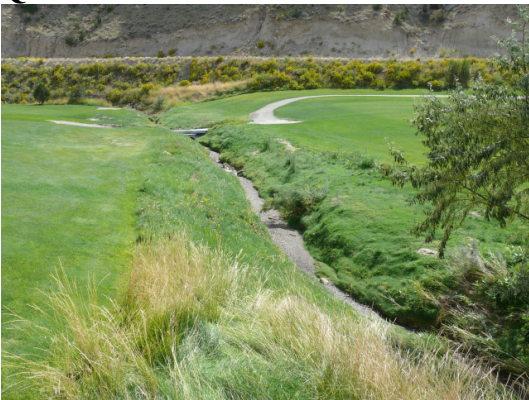
Q.

Garley Wash having lost a great amount of streambed due to silting. The tall grass outlines high water mark during flood.

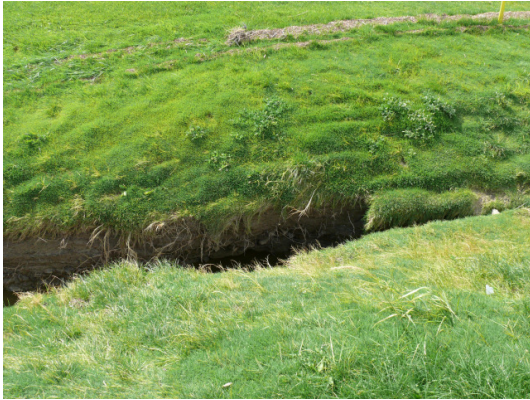
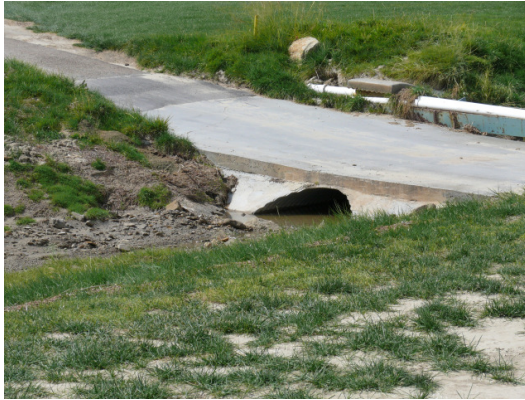
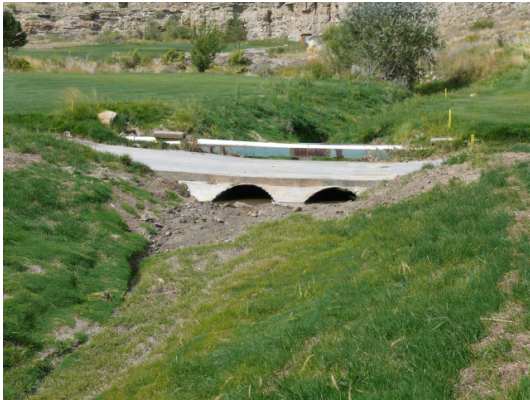
Pictures R-T illustrate again the decreasing depth of Garley Wash due to silting. At flood level the bridge shown in pictures S and T is completely inundated with water.

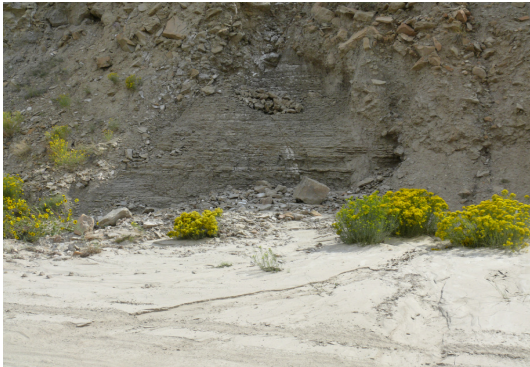
U.

Picture U shows more erosion from Cliffside onto county road.

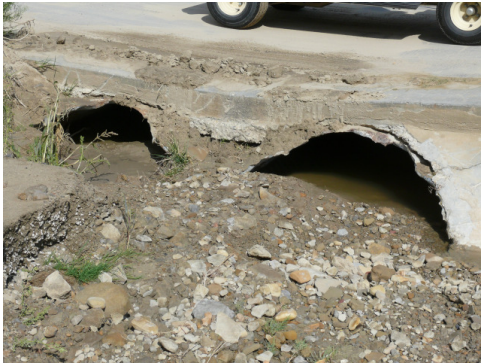
V.

Another picture of clogged culverts in Garley Wash.

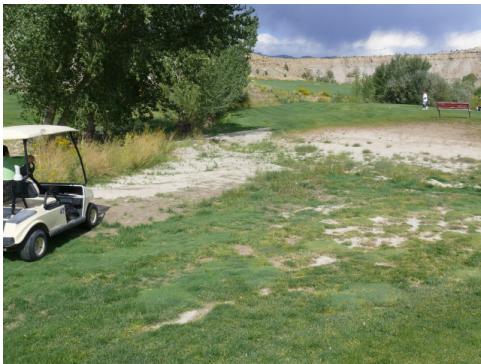
W.

More evidence of sediment being deposited onto course because of flooding, notice the trees that clog the drainage.

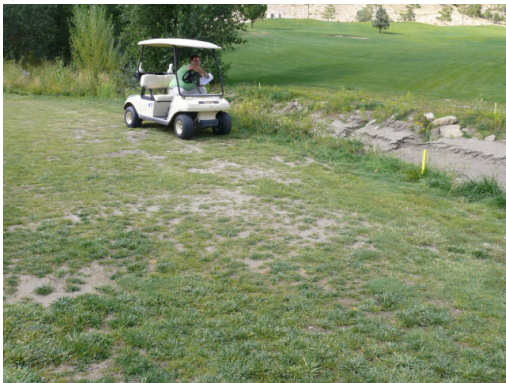
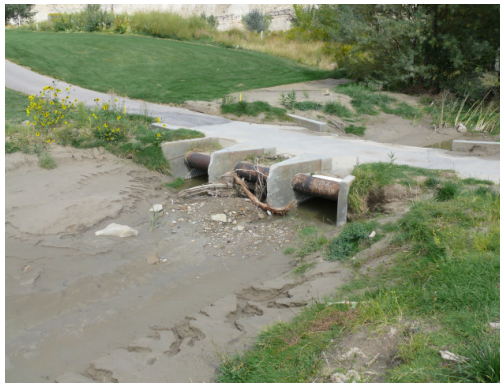
Pictures X and Y show high water mark during flood in Garley Wash.

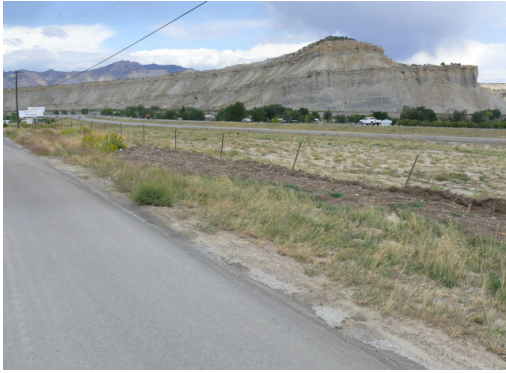
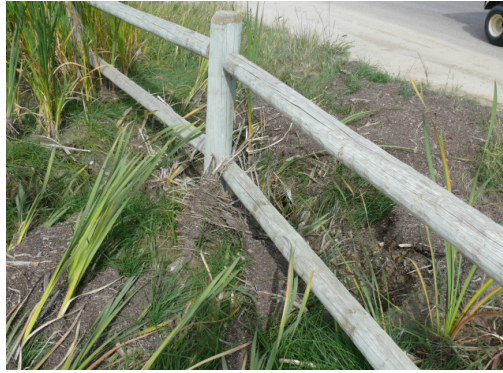
Pictures Z and AA show the drainage that drains the back nine of the golf course as it goes under the road that parallels HWY 6. Notice all the debris in picture Z that has been washed across the road because of clogging within the culvert.

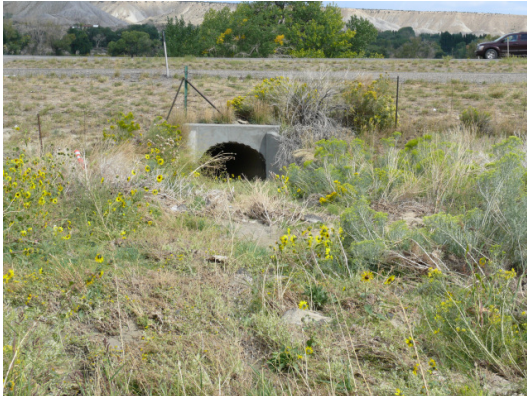
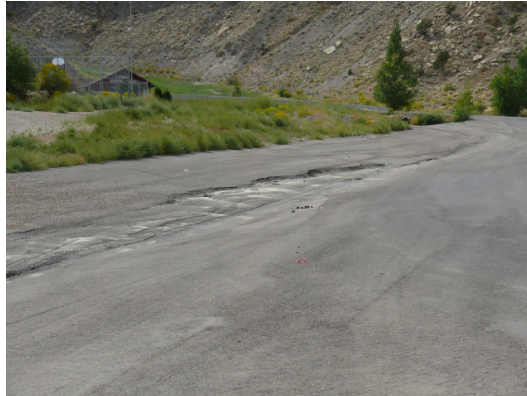
The above pictures show another drainage area that flows east from the driving range underneath HWY 6. The paved road itself has become the ditch.

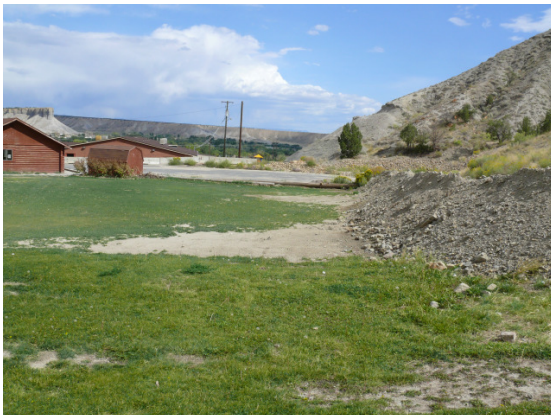
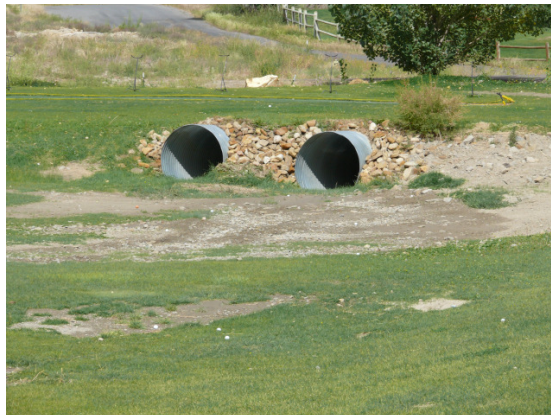
These pictures show erosion that has occurred from water flow downhill from the driving range.

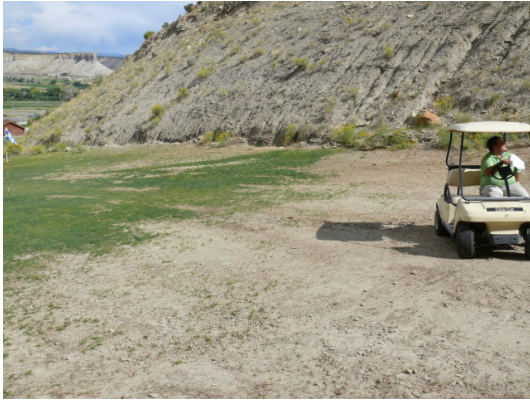
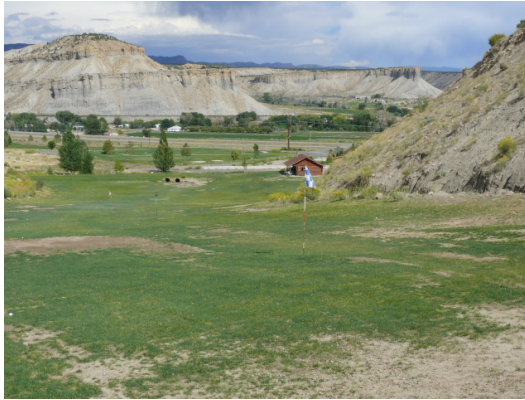
These pictures show the top of the driving range and the ditch work they have done to further mitigate problems.

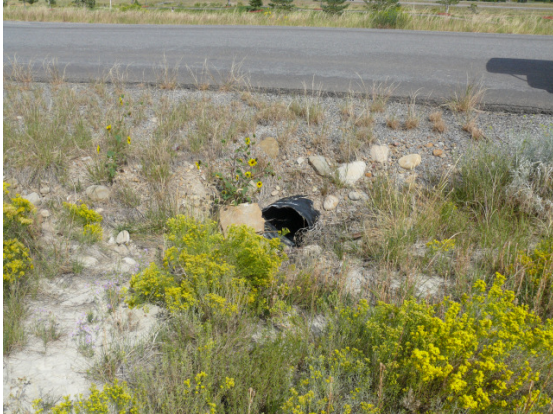
HH.

Culvert that drains underneath the road west of the back nine.
